# Safety Inspection Report

Annual Inspection

## Viking Playground

Site name: **Viking Playground**  
Date of inspection: **11 November 2021**  
Inspector: **Dan Clifft**

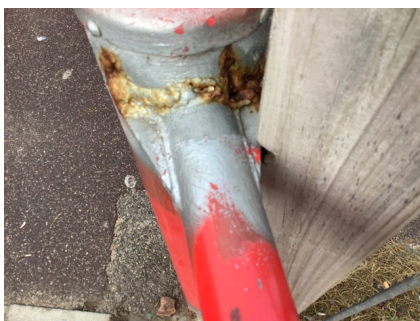
Entrapment on side(s) of the gate.

Adjust gate / posts / fit new rubber buffer to ensure a spacing of at least 12 mm throughout the range of the gate to remove the entrapment. The 12 mm gap also should apply on the hinge side of the gate.

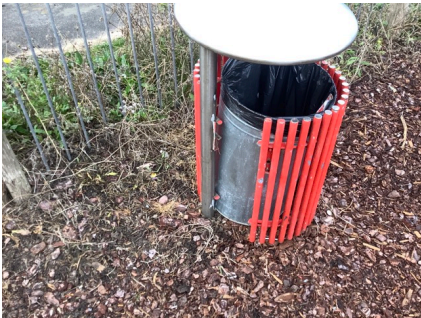
The item is unlocked.

Lock.

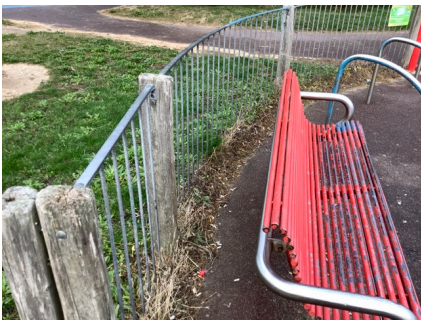
RoSPA recommend a minimum distance of 1 m between seat and fence. This is to reduce the likelihood of children vaulting the fence via the seat.

No reasonably practicable action is identified.

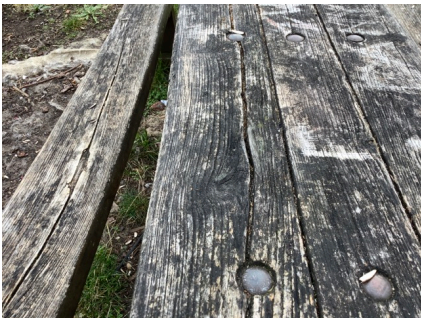
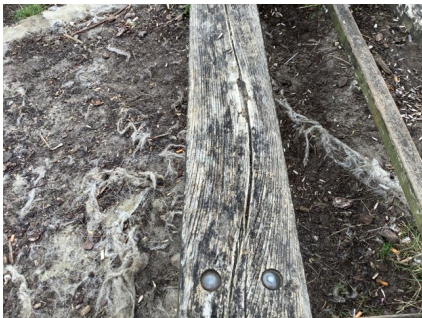
Item is cracked.

Monitor shake, replace board if necessary.

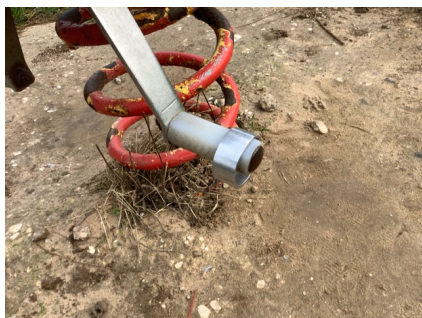
Protruding handles / foot rests.

No reasonably practicable action is identified.

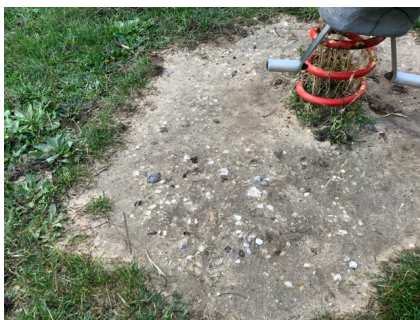
Surface is uneven.

The surface is wearing exposing sharp protrusions. Consider installing grass mats to help with wear.

Make good.

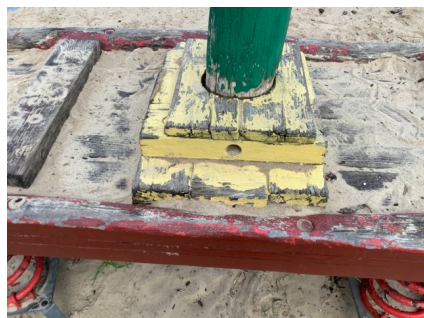
Cap missing.

Replace.

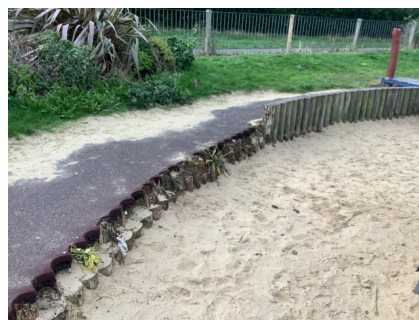
Timber is decayed.

Tarmac path forming hard / sharp projections. Inspector recommends that the remaining timber logs are removed and that an alternative border is installed.

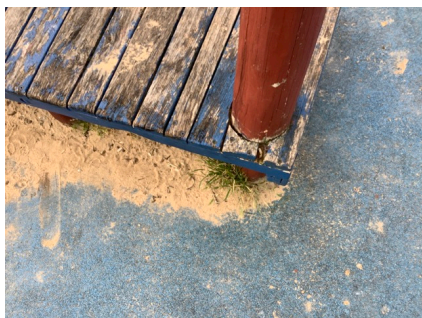
Item is damaged.

Repair.

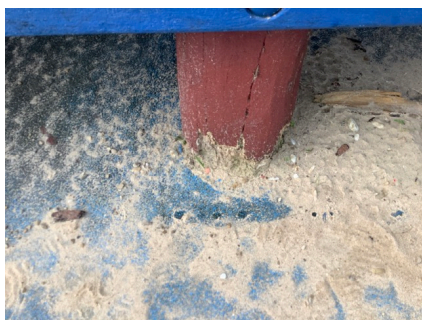
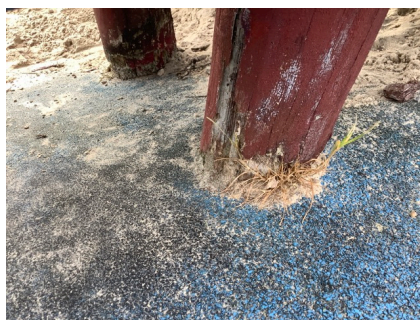
Timber is decayed.

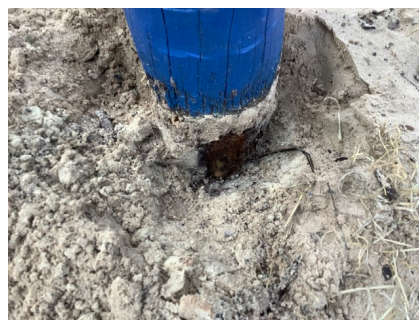
Timber is decayed.

Decay on all support posts below ground level this may be limited to outer layers of timber.

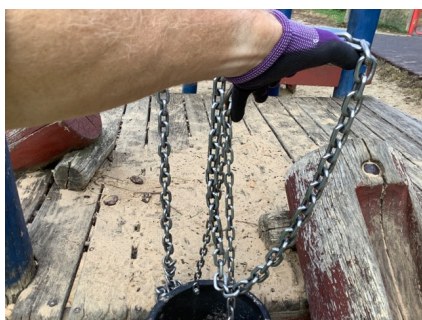
Timber is not in good condition.

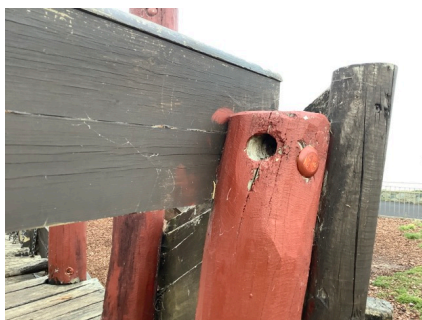
Cap missing.

Replace.

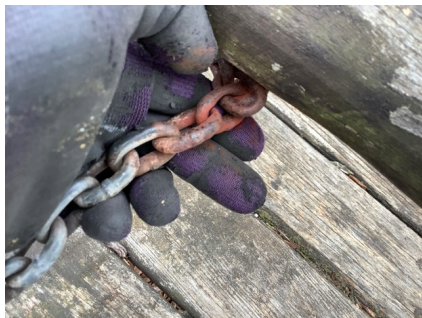
Some chain wear.

Monitor for further deterioration and replace before 40% wear.

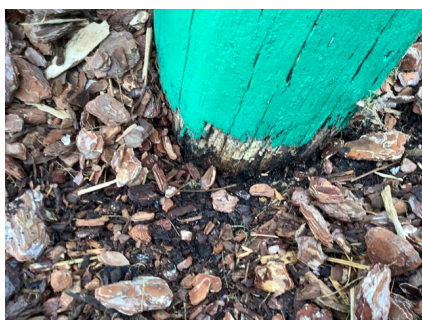
There is decay to timber components which may affect structural integrity. We do not recommend replacing rotten supports with timber posts which are directly set in the ground due to the increased problem of timber rot, especially in posts in contact with the ground.

Inspector believes the decay may be limited to the outer layers of timber. Monitor closely. Ensure posts are secure in their foundations.

We recommend resistograph testing to determine the internal condition of the timber,. We can undertake this testing at additional cost. Please contact us for details., Read the notes for further action.

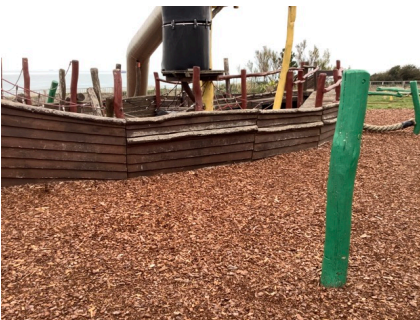
Item has some parts missing.

Hammock missing.

Replace the missing parts.

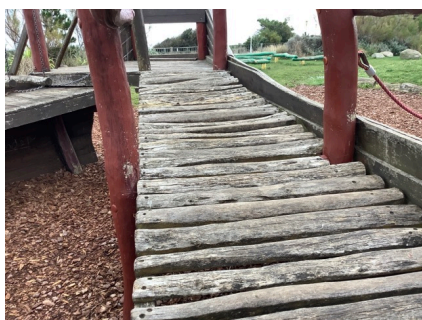
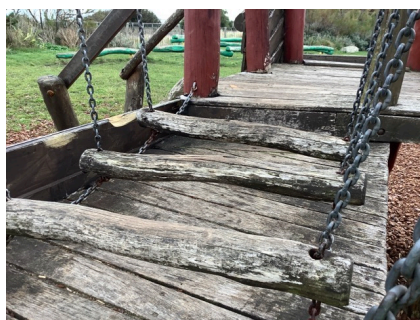
Timber is not in good condition.

Various timbers around unit decaying. Monitor decay, replace timbers as necessary.

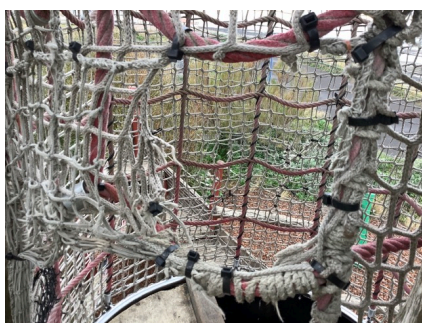
Rope gaps at top of mast tunnel. Some mesh damaged. Replace. The net must be well maintained and checked regularly to ensure that there are no gaps present which a person may be able to pass through. Monitor the condition of the net very closely.

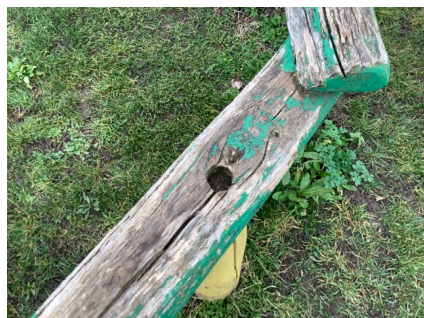
Cap missing.

Replace.

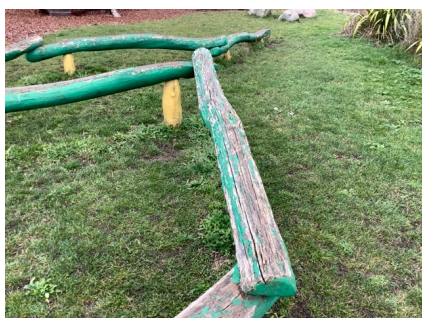
Timber is decayed.

Decay appears to be limited to the outer layers of timber - monitor and sand back any splinted edges as required.

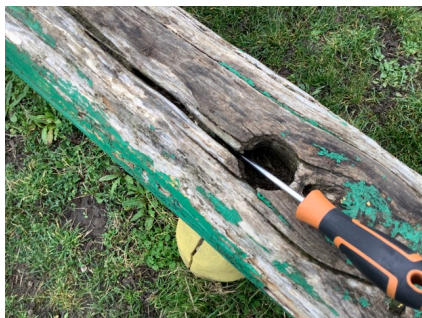
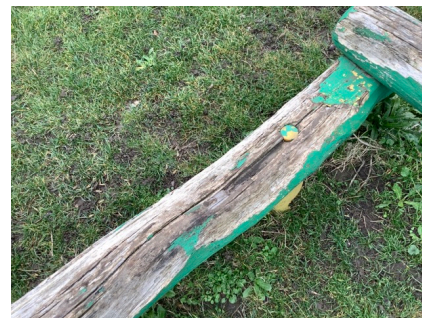
Timber is not in good condition.

Remove rough edges and monitor for decay.
