Ramsgate Berth 4&5 Pontoon –
Condition Survey

5773-001-M-T.030 Rev. C

Thanet District Council

26th November 2019

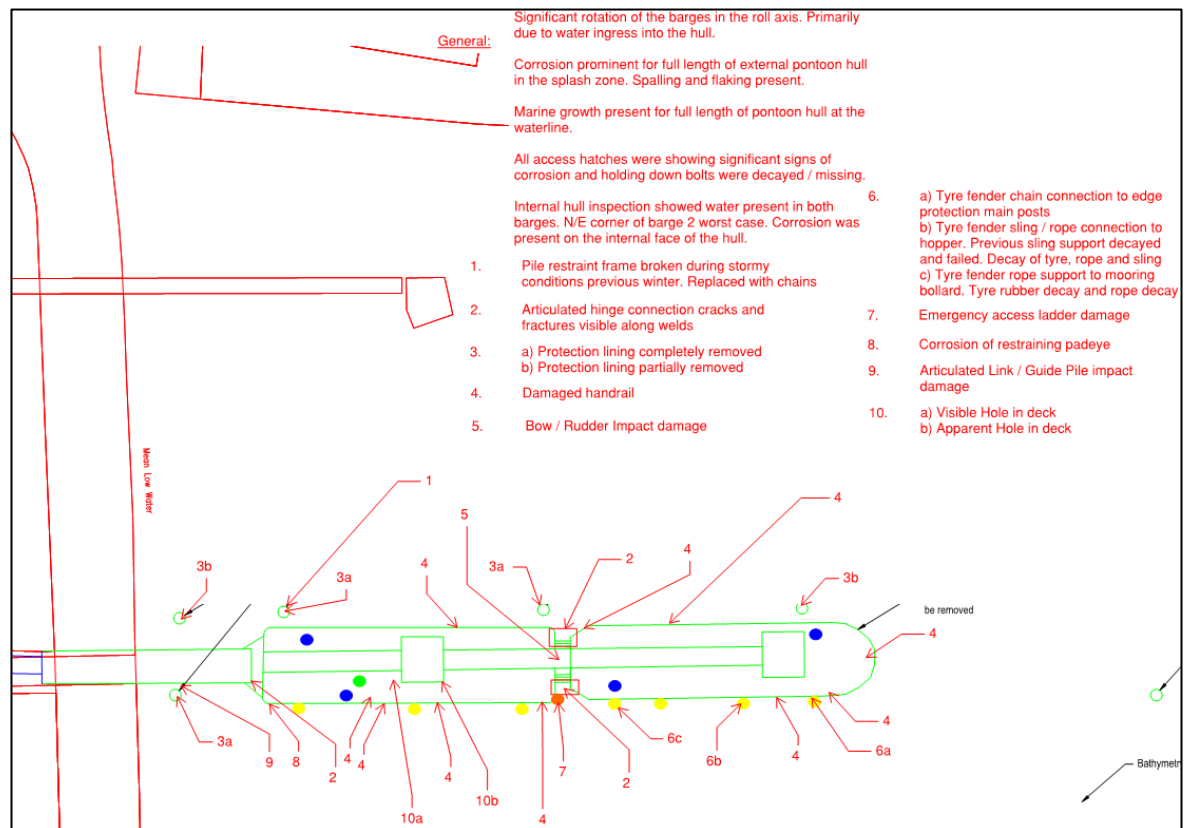
Figure 12 Visual Demonstration of Barges Roll

The general findings of the inspection are summarised in the below sketch. The subsequent sections of this report provide further detail on the various elements of the berth.

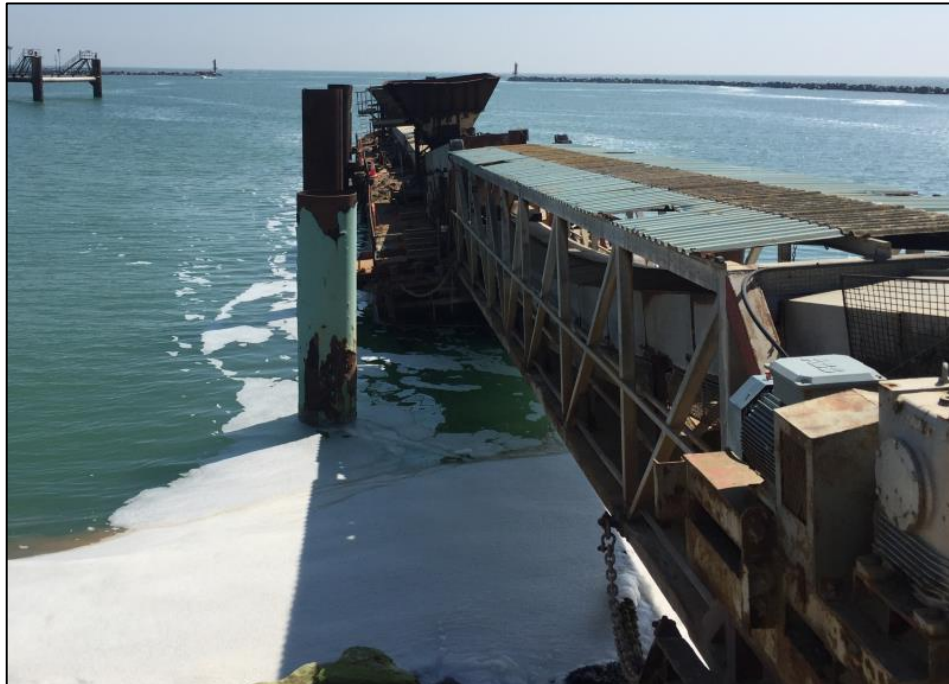
Figure 13 Visual Demonstration of Barges Roll

Upon approaching the barges, it was clearly visible that the two barges were not level. Both barges were clearly rotated in the roll axis. This is most likely to be due to water ingress into the hull (refer to later sections of the report for details). Other contributing factors may be the barges being undersized for the actual berthing conditions / loads, and a lack of restraint offered by the restraint frames to the guide piles – however, there was no direct visual evidence to support this, and a nautical assessment has not been undertaken.

Freeboard measurements were taken at each of the four corners of each pontoon – as shown below. These figures demonstrate the presence of this rotation.

Freeboard Measurement Corner Reading	Barge No. 1 (m)	Barge No. 2 (m)
Northwest	1.20	0.80
Northeast	1.45	0.70
Southeast	1.90	0.90
Southwest	1.55	1.05

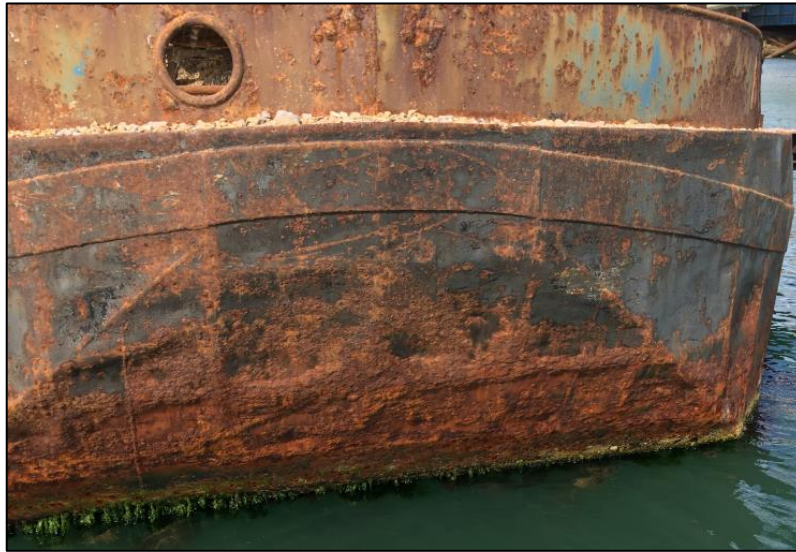
Figure 14 Barge No.2 Bow

It was clearly visible that there were significant areas of the hull affected by corrosion on both barges. This ranges from small localised spots, to significant amount of areas showing heavy corrosion and spalling on the hull.

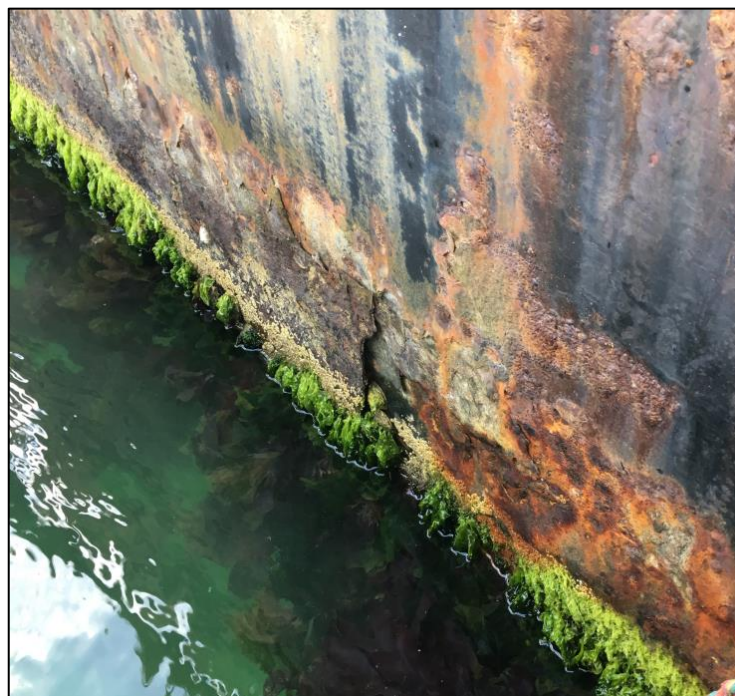
Figure 15 Barge No. 1 Hull (Northside)

Locally, where spalling was present, significant loss of section was visible. The full extent of loss of section cannot be concluded from a visual inspection. However, considerable reduction in section has occurred reducing the structural performance of the barge, and its remaining design life.

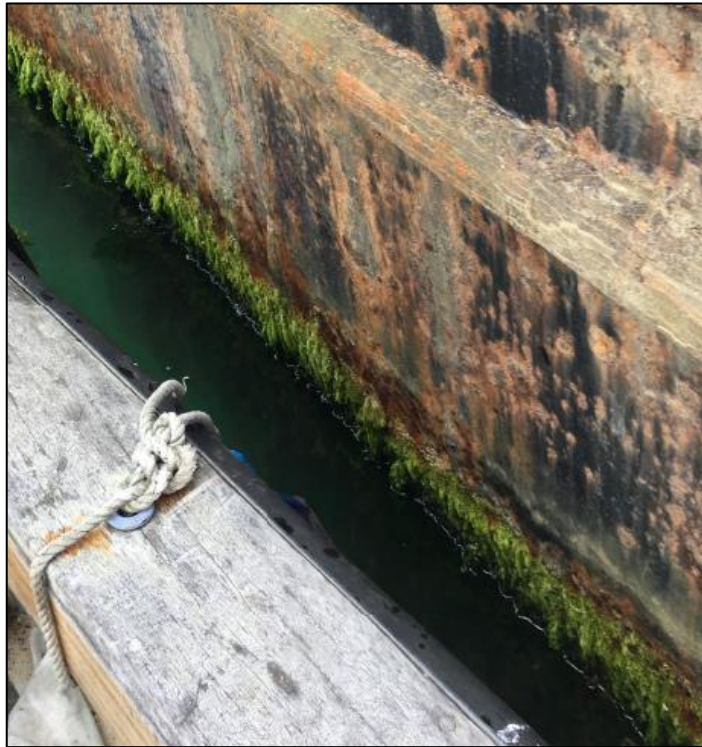
Figure 16 Barge No. 2 Hull (Northside)

Furthermore, a significant amount of marine growth was visible along the tidal level of the barges.

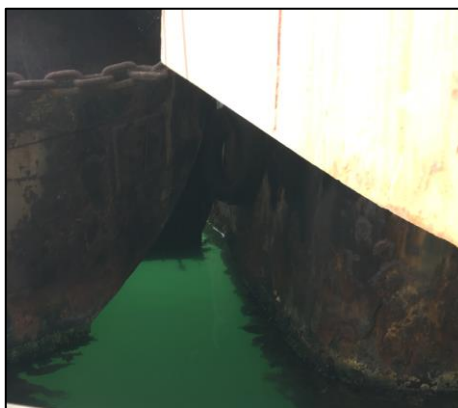
Figure 17 Barge No.1 bow, Barge No. 2 stern

The bow of one of the barges (barge 1 on the right) is showing significant deformation and impact damage. There is a tyre fender positioned at this location indicating that there is potential impact from the adjacent barge (barge 2 on the left).

It is apparent that the tyre fender isn't sufficient and the rudder of barge 2 impacts barge 1 in rougher tidal conditions. This could lead to significant damage to the hull and cause water ingress.

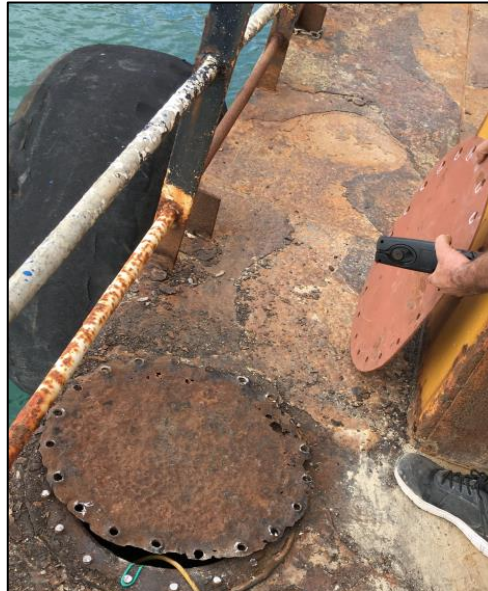
Figure 18 Barge No. 1 Southside Access Hatch

The access hatches are showing significant sign of corrosion and loss of section. One of the access hatches on barge no. 1 has already been replaced.

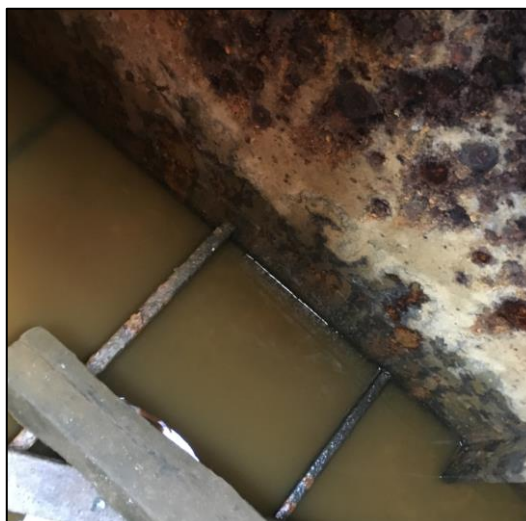
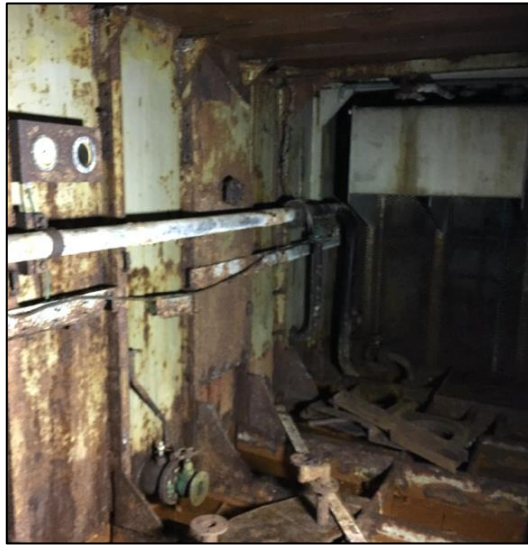
The internal face of the hulls were also corroded. However, the extent and severity was significantly less than the external face. The combined effect of the external and internal corrosion, has a considerable effect on the structural performance of the barges.

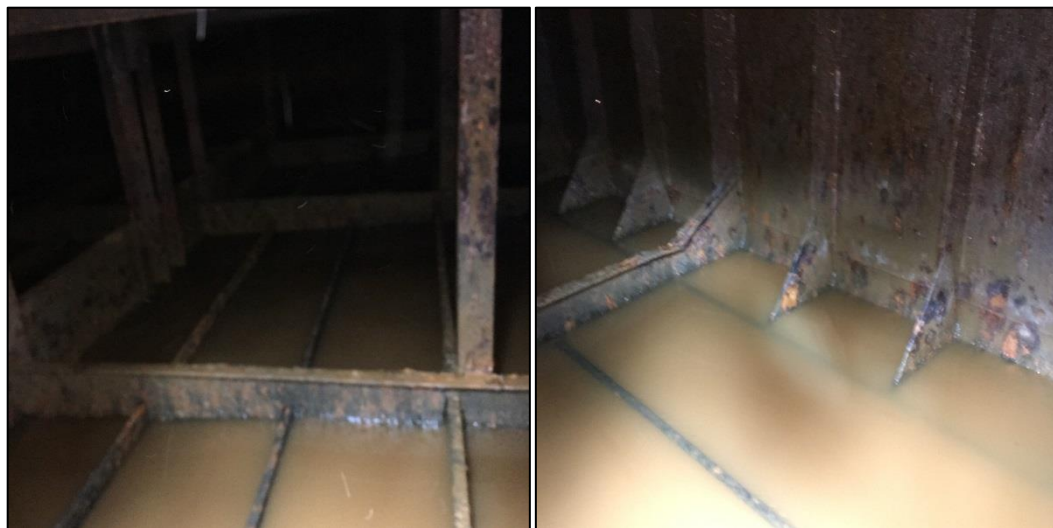
Figure 21 Barge No. 2 (N/E Corner)

It was clear that water ingress has occurred into the barges. Speaking with Port of Ramsgate representatives on site, it was clarified that intermittent pumping of water out from the internal structure has been required, dependant on weather conditions. Barge No. 2 showed higher levels of water ingress in comparison with barge No. 1 – particularly in the northeast corner.

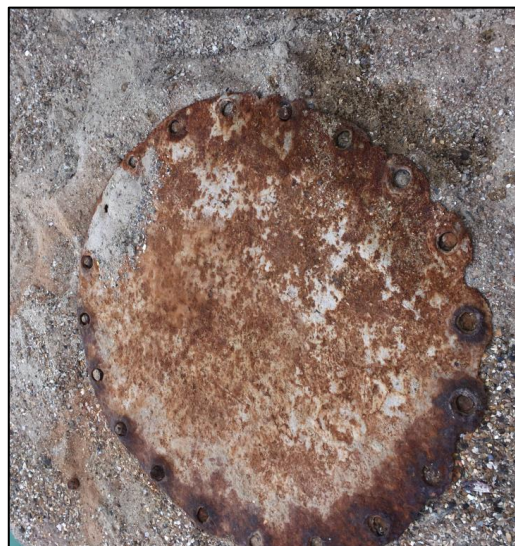
The water ingress into Barge No. 1 could have been through a number of areas. The access hatches aren't fully sealed and there was a hole visible in the deck. Additionally, it was ascertained that another hole is present in one of the inaccessible areas, below the conveyor in barge No.1. There was no evidence of a water ingress point in barge No.2, except for the seal quality between the access hatches.

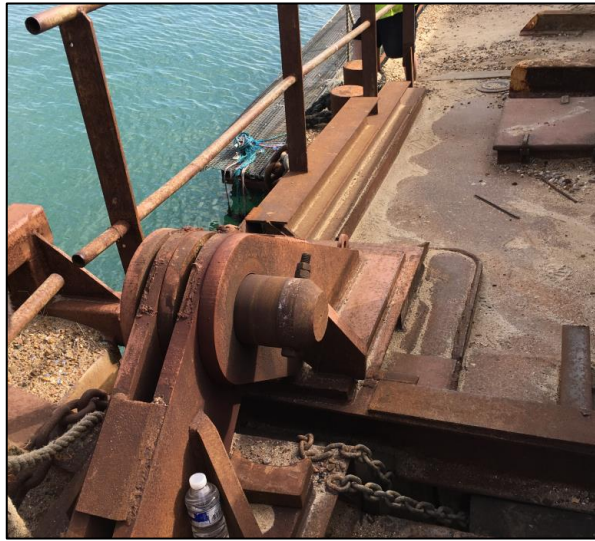
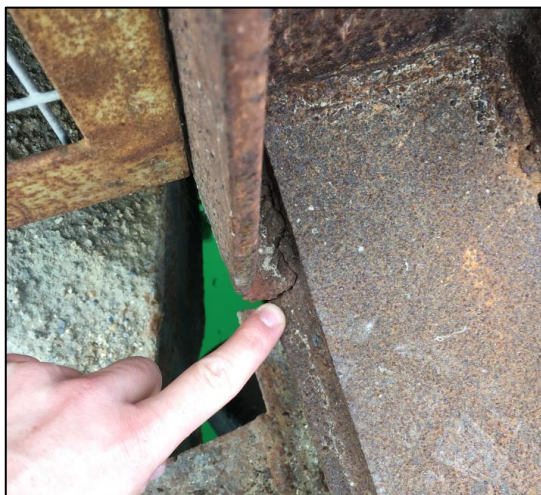
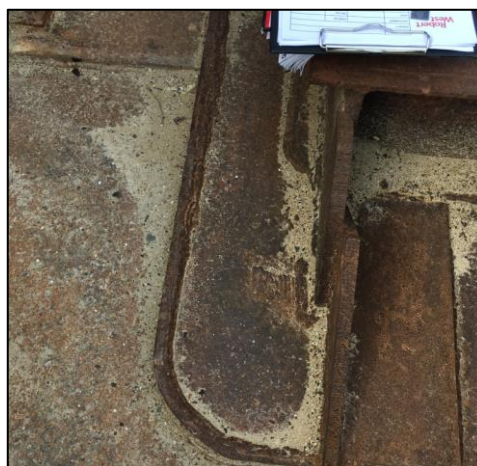
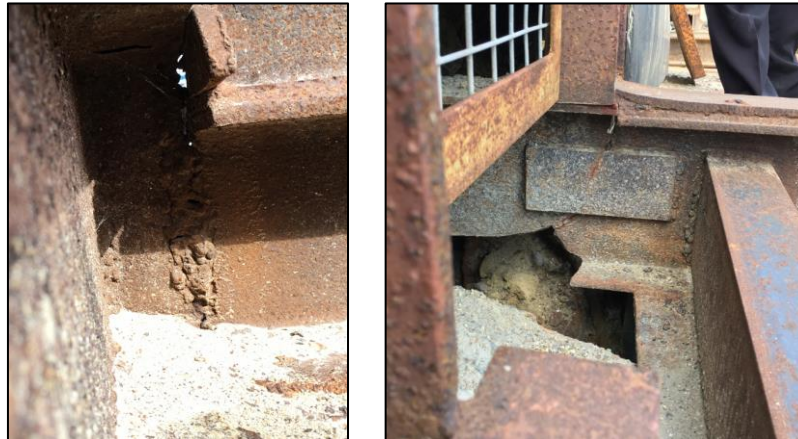
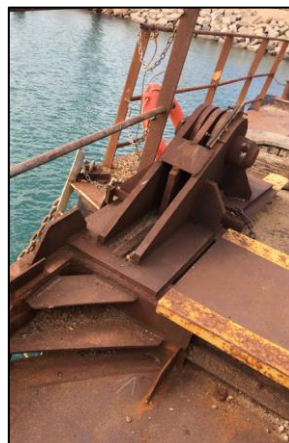
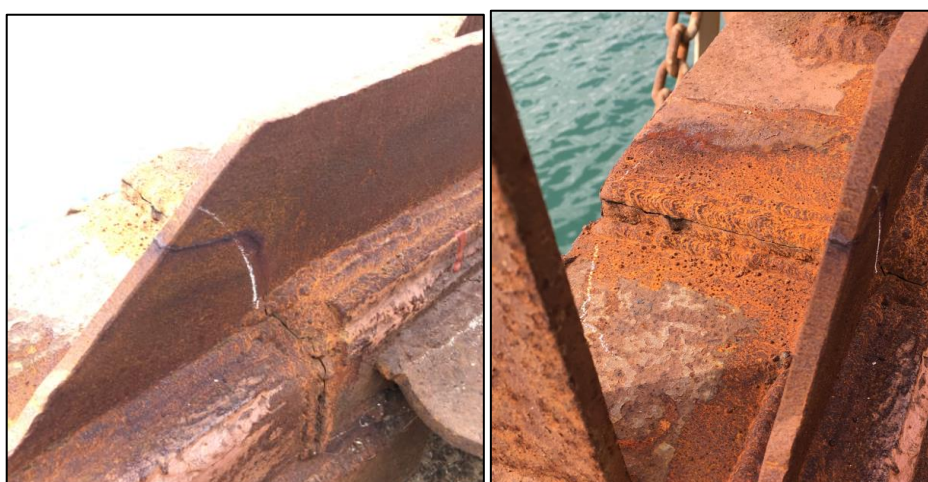
The hinge connections between both barges had clear signs of hairline cracks and fractures along the welds. It was clarified with on-site representatives of the Port of Ramsgate, that maintenance / repair welding has needed to be regularly carried out in these areas. Multiple layers of welding and decay of welds were visible at crucial joints between the hinge connections and the barge's hull.

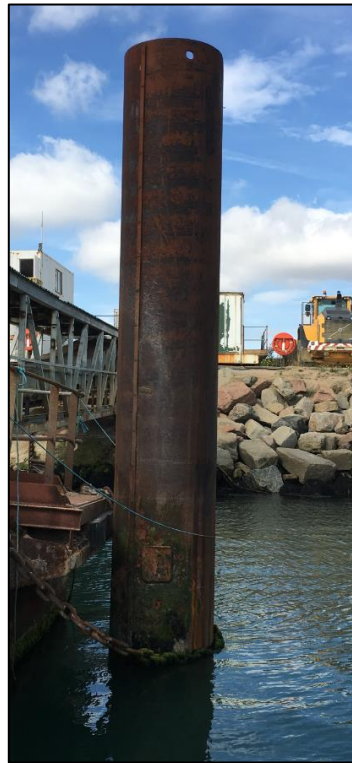
Figure 30 Barge No.1 Guide Pile (NW Corner)

In general, the restraint piles of the pontoon were in good condition. There were some areas where local corrosion was present, especially near the position of the barge restraint frames.

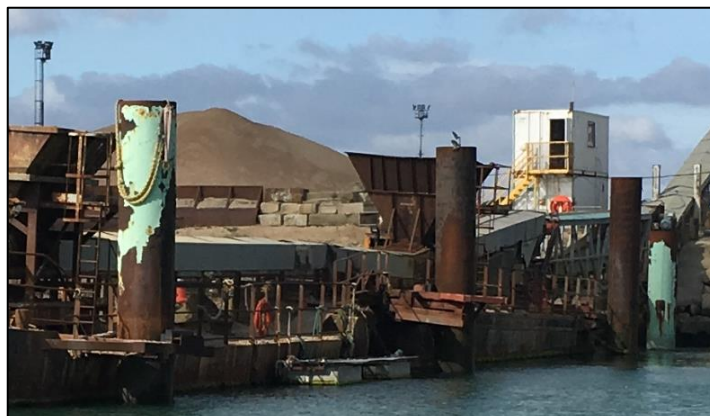
Figure 31 Barges Guide Piles

The protective coating had totally removed in two of the steel piles and partially removed in the other three.

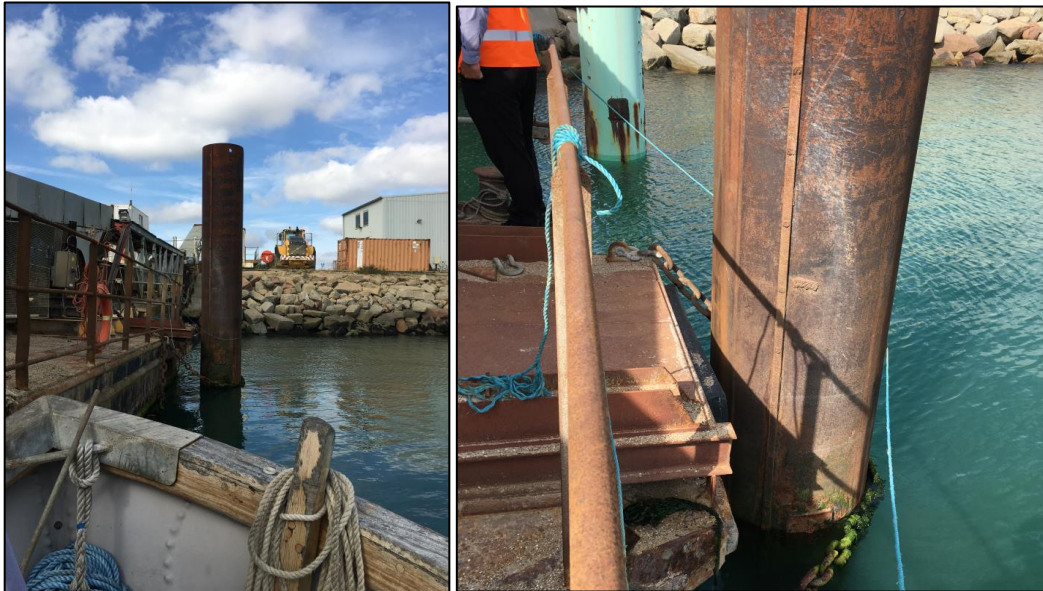
Figure 32 Guide Pile Broken Restraint Frame (Chain Replacement)

For the restraint pile to the northwest corner of Barge, there was no steel guide frame. The restraint was instead made up of steel chains hooked onto a pad eye welded onto the barge deck. This allows a larger range of movement in comparison to the restraint frame.

It's understood that the restraint frame element had broken off the previous winter in stormy conditions.

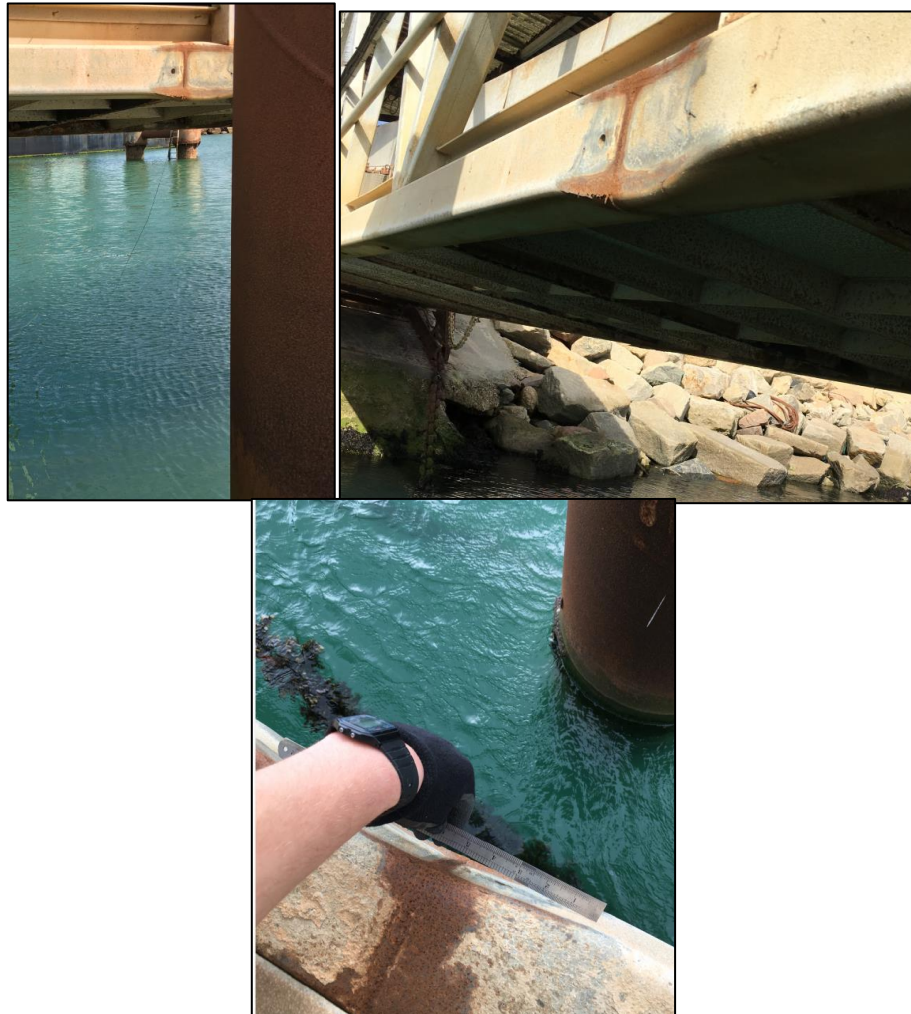
Figure 34 Articulated Linkspan Guide Pile Damage

There was significant deformation of the lower main chord of the articulated linkspan. This has been created by the articulated linkspan impacting one of the circular guide piles. It was not concluded if this due to wave, berthing or mooring forces.

No rupture of weld or connections of the nearby main chord, column/brace connection were visible.

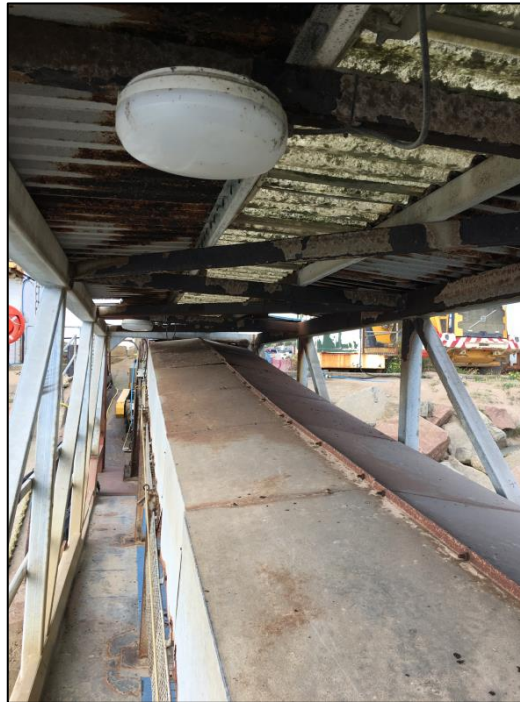
Figure 35 Articulated Linkspan

As stated in section 1.3, inspection of the articulated linkspan isn't part of the scope of works. However, corrosion was visible on the majority of the upper level sections of the articulated linkspan.

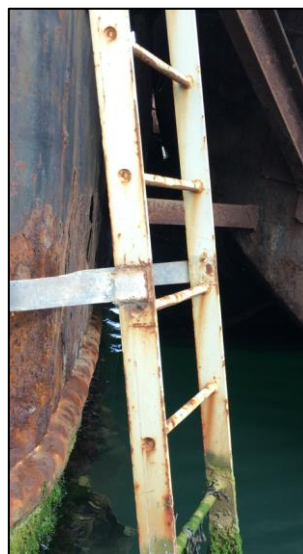
Figure 36 Emergency Access Ladder (Southside)

The emergency ladder access of the southward face of the barge did show some level of corrosion on the ladder rungs and stringers. However, the extent of corrosion was not significant.

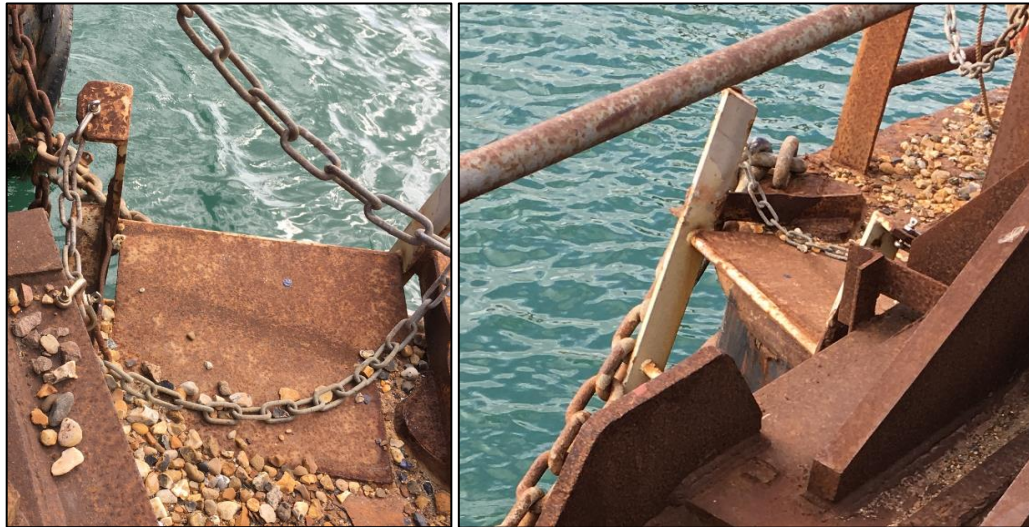
Figure 37 Emergency Access Ladder Connection (Southside)

The top end of the rungs did show slightly more corrosive loss, and it was visible that there was a recent installation of a new access chain link.

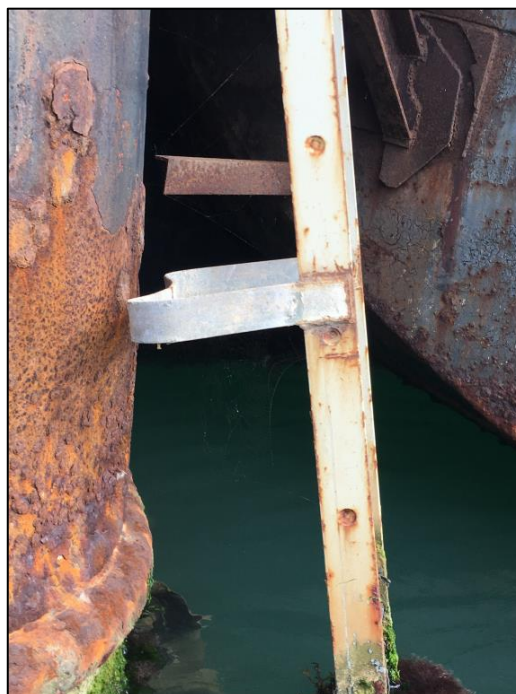
Figure 38 Emergency Access Ladder Damage (Southside)

The mid-level backing support of the ladder shows impact damage and deformation. This clearly shows that loads are generated to deform the backing support. This may be due to the aggregate vessels berthing along this face and the position of the ladder not being fully compatible with the current position / arrangement, thus resulting in an accidental impact.

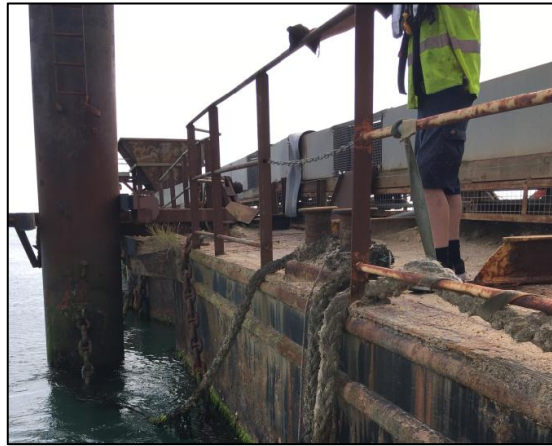
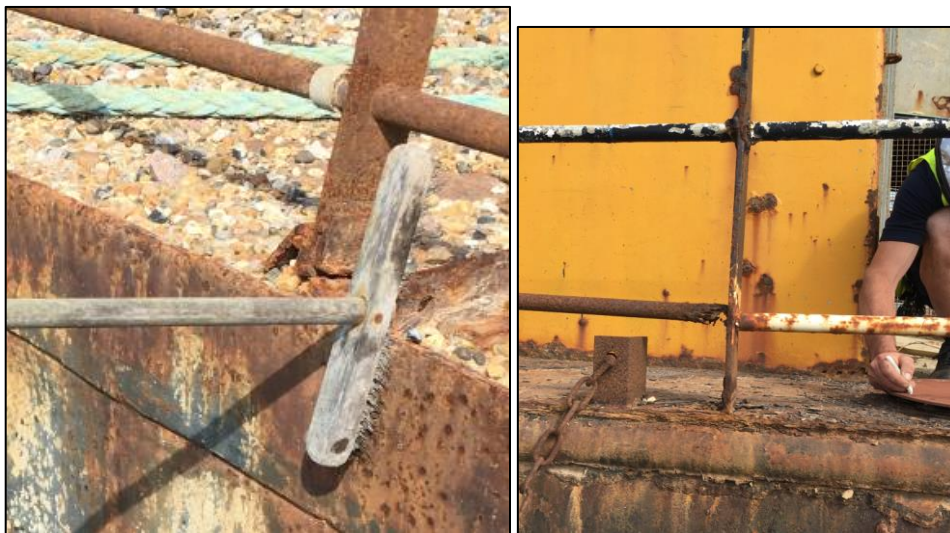
Figure 39 Edge Protection Handrails

The edge protection handrail was visibly corroded along the full length on both barges, and damaged in certain points. Varying levels of corrosion were present, with significant loss of

section at localised points. This has produced localised sharp edges to the main handrail, and middle rail, and loss of support to limited number of main posts of the edge protection.

Some sections have already been replaced with chains.

In one instance, the edge protection main post is used as a restraint connection for one of the rubber tyre fenders.

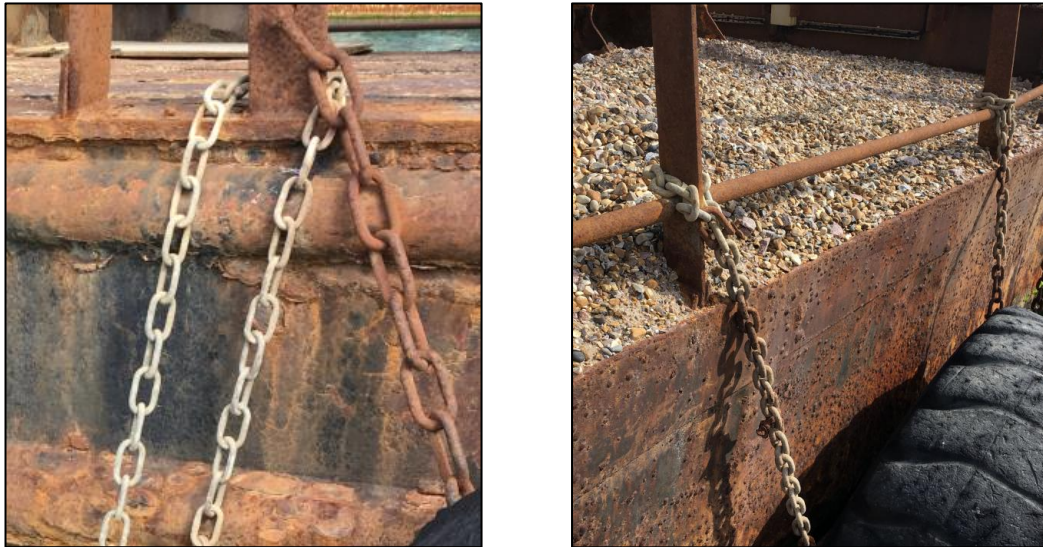
Figure 40 Fender (Chain Support)

Various levels of corrosion were visible on the fender restraint chains which support the fenders.

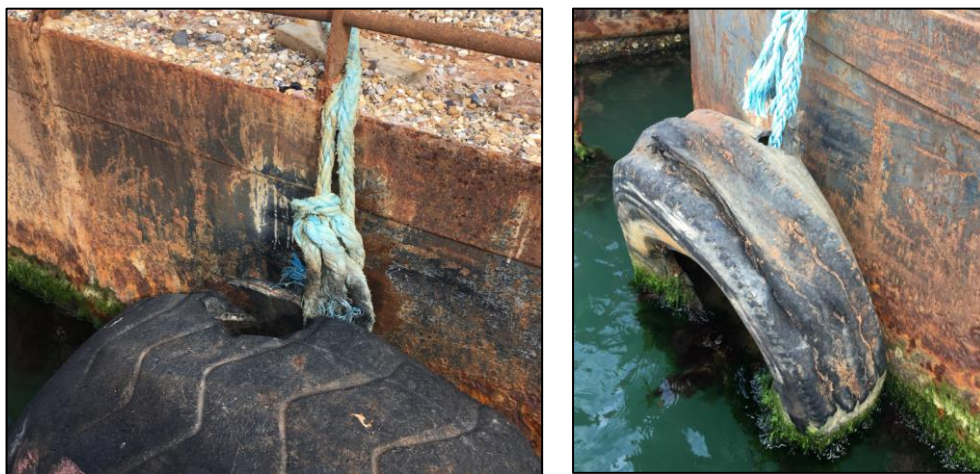
Figure 41 Fender Decay (Rope Support)

There are areas of decay visible on the rubber elements on a limited number of tyre fenders. An additional rubber tyre fender has been installed in one instance to supplement an existing tyre fender.

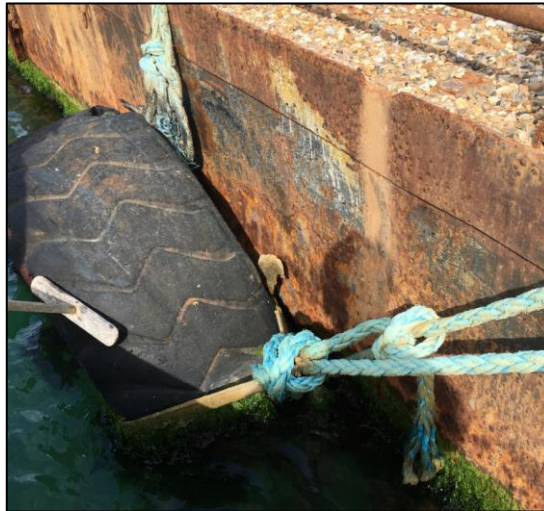
Figure 42 Fender Sling / Rope Support Decay

Decay is also visible on the slings and rope connecting one of the fenders to the barges. It is also visible that the sling / rope connection had previously failed, and another sling had to be installed.
