Ramsgate Berth 4&5 Pontoon –
Condition Survey

5773-001-M-T.030 Rev. C

Thanet District Council

26th November 2019

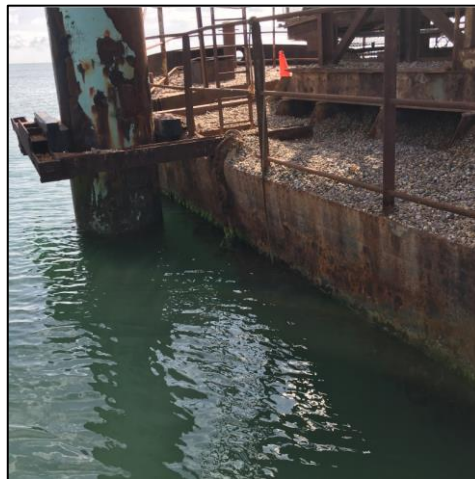
Figure 33 Functioning Guide Pile Restraint Frame

It's understood that the restraint frame element had broken off the previous winter in stormy conditions.
