# Safety Inspection Report

Annual Inspection

## Viking Playground

Site name: **Viking Playground**  
Date of inspection: **11 November 2021**  
Inspector: **Dan Clifft**

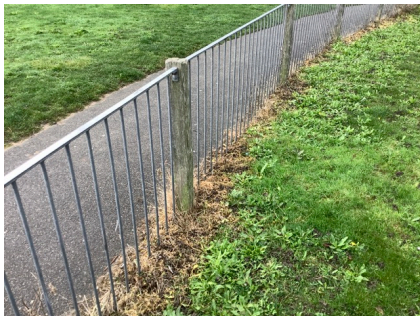
Posts showing signs of decay with a number of posts snapped at ground level.  
Replace decayed posts.

Replace rotten timbers.

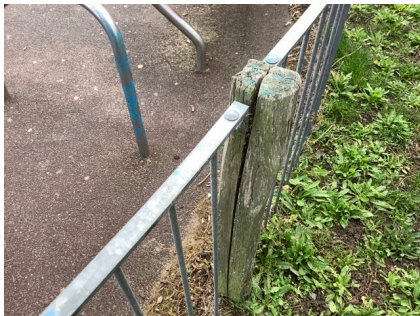
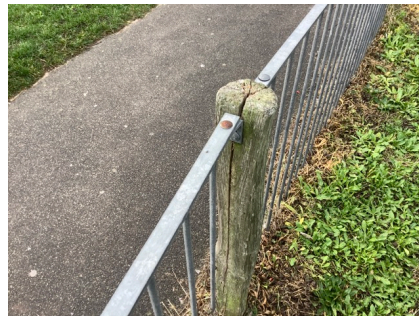
The shake is running through the fixing leaving the panel loose.

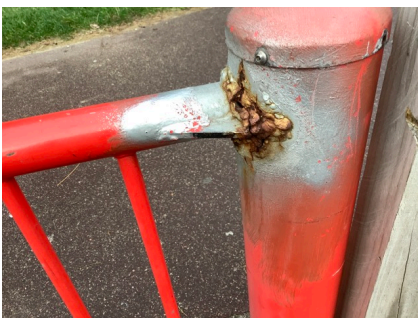
Welds are cracked.

Repair.

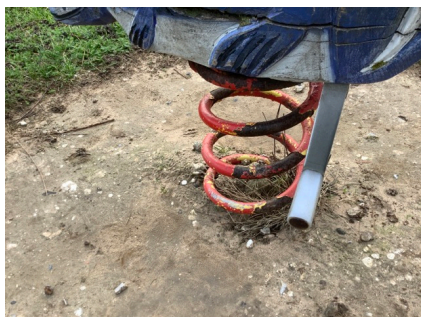
Paintwork is in poor condition.

De-scale back to good base material and coat with lead free paint, using appropriate precautions. Repairs may be necessary where corrosion is severe.

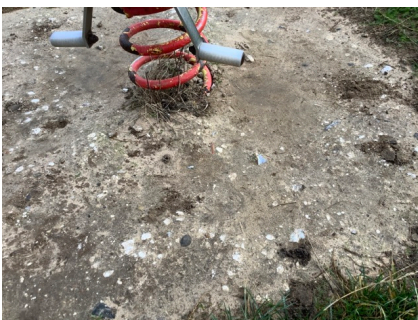
Surface is wearing.

The surface is wearing exposing sharp edges. Consider installing grass mats to help with wear.

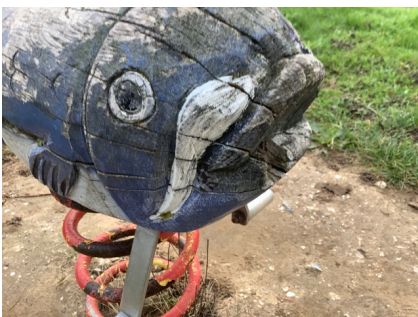
Timber is decayed.

Sand back rough / decayed edges.

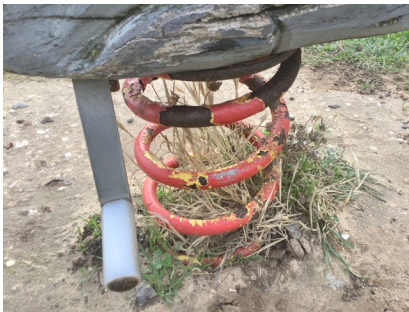
Paintwork is in poor condition.

De-scale back to good base material and coat with lead free paint, using appropriate precautions. Repairs may be necessary where corrosion is severe.

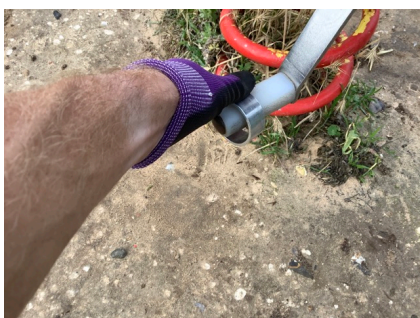
The surface is wearing exposing sharp protrusions. Consider installing grass mats to help with wear.

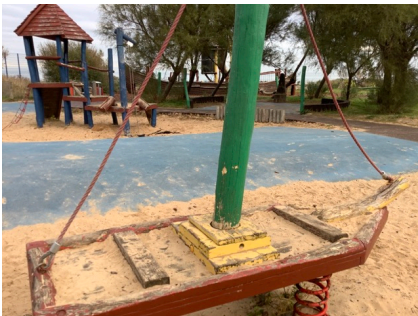
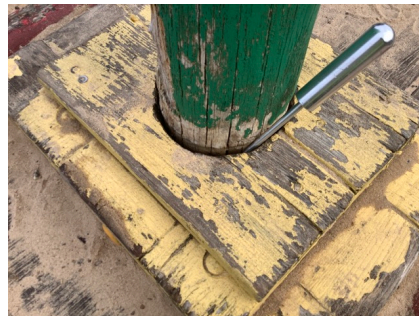
Fixtures loose or missing.

Central mast loose. This is creating potential crush points.

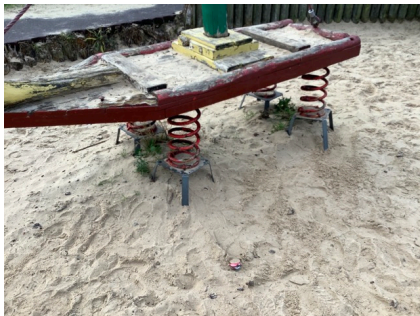
Loose in ground.

Foundation plates x 3 loose. Reset.

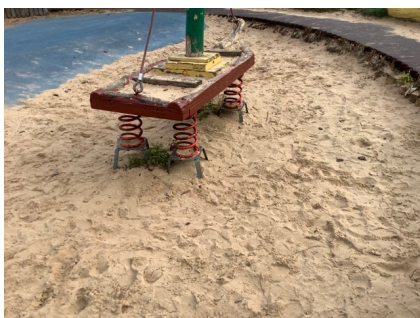
Loose fill levels are too low to provide adequate protection.

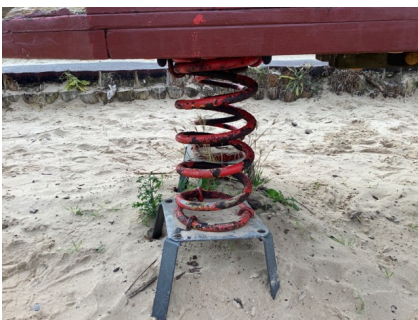
Paintwork is in poor condition.

Substantial corrosion on springs. Repaint to protect.

De-scale back to good base material and coat with lead free paint, using appropriate precautions. Repairs may be necessary where corrosion is severe.

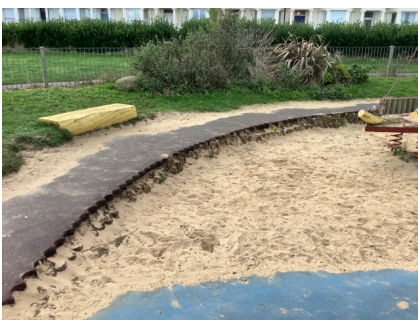
Tarmac path forming hard / sharp projections. Inspector recommends that the remaining timber logs are removed and that an alternative border is installed.

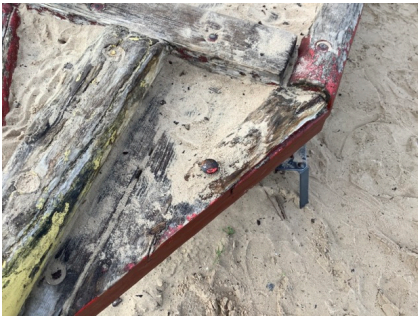
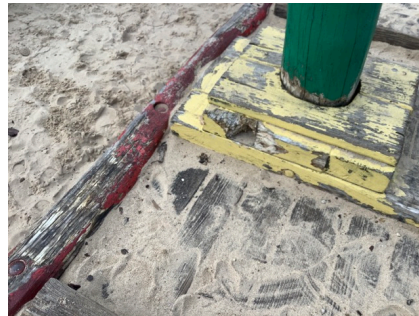
Timber is decayed.

Replace affected parts.

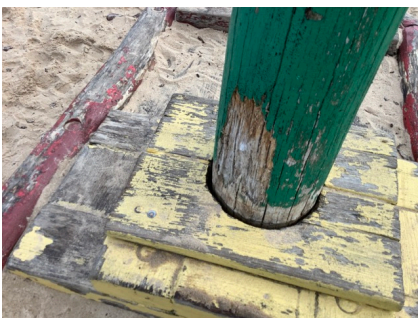
Timber is decayed.

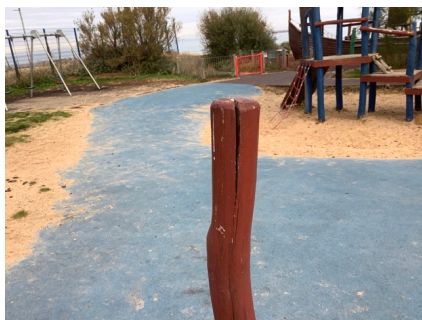
Item is damaged.

Repair.

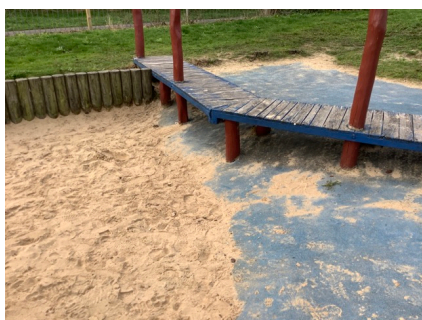
Timber is decayed.

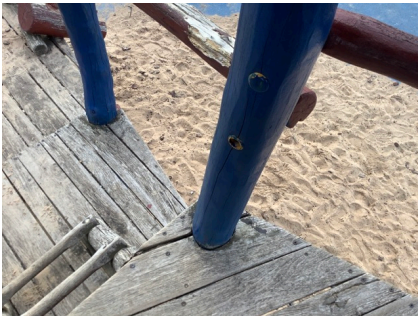
Cap missing.

Replace.

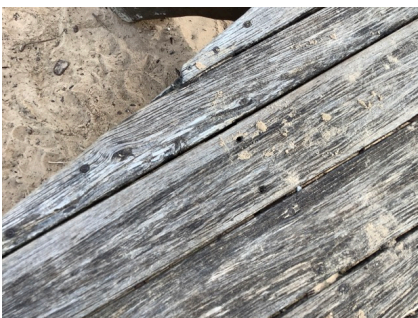
Fixtures loose or missing.

Replace.

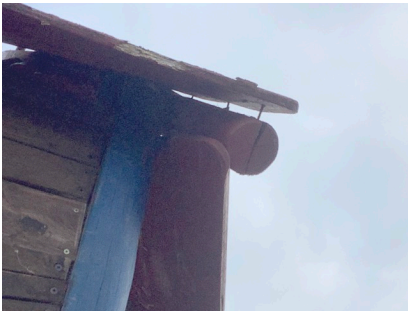
Fixtures loose or missing.

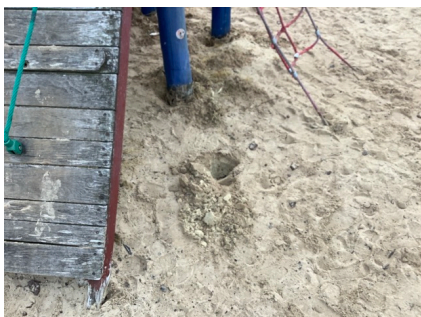
Loose fill levels are too low to provide adequate protection.

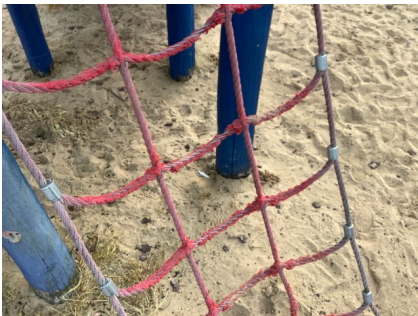
Ropes heavily worn. The inspector recommends replacing.

Replace the worn ropes.

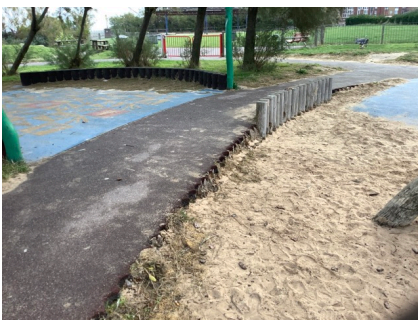
Timber is decayed.

Remaining concrete forming hard / sharp projections. Inspector recommends that the remaining timber is removed and that an alternative border is installed.

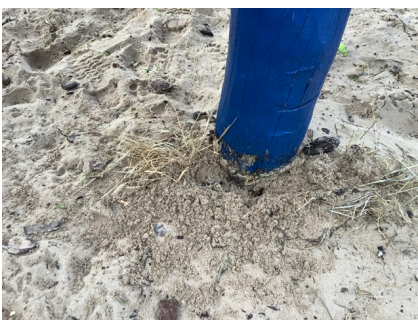
Timber is decayed.

Decay on all support posts below ground level this may be limited to outer layers of timber.

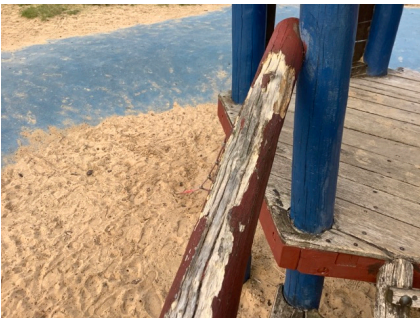
Timber is not in good condition.

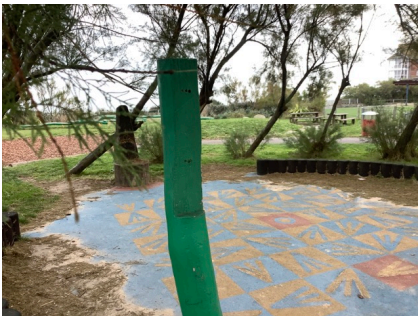
Item has some parts missing.

Replace the missing parts.

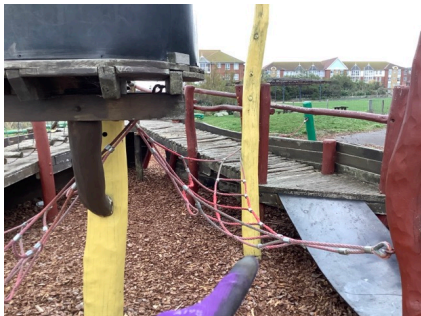
Loose in ground.

Excavate foundation and ensure secure.

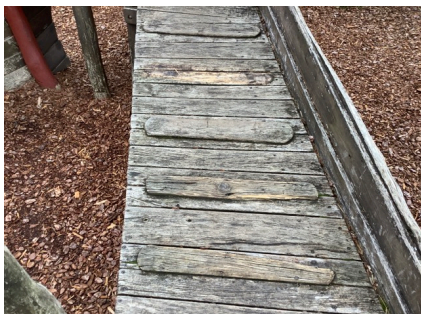
Missing item.

Anti-slip treads missing and damaged. Replace.

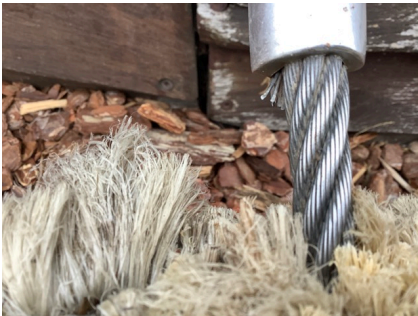
Item has some parts missing.

Hammock missing.

Replace the missing parts.

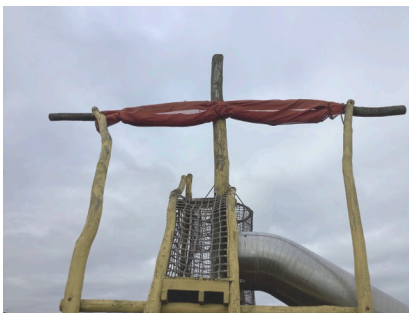
Inspector unable to gain access to the the top timbers to make comment on condition of fixings and timber. Recommended a thorough inspection is carried out due to the amount of flex in the structure.

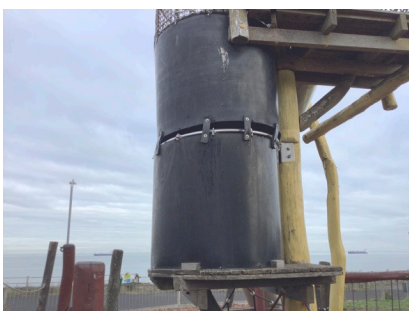
Infill cladding leading to crows nest. The area has enclosed platforms that cannot be seen from outside. This forms a security risk to users and equipment. Recommend changing to mesh cladding.

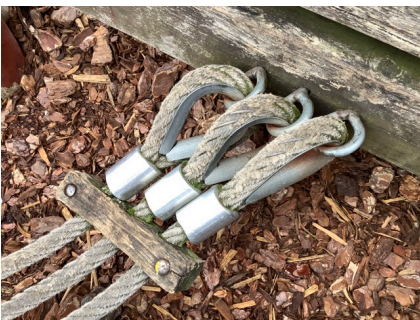
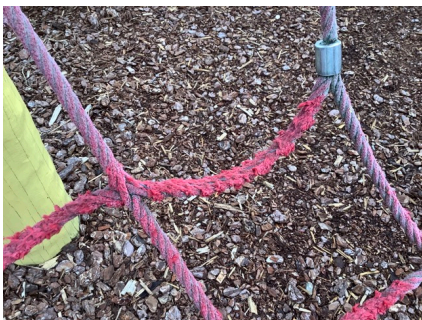
The rope has been taped, making it impossible to determine the extent of damage.

Remove the tape to determine the full extent of the damage.

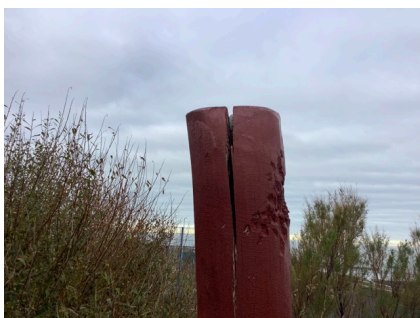
Timber is not in good condition.

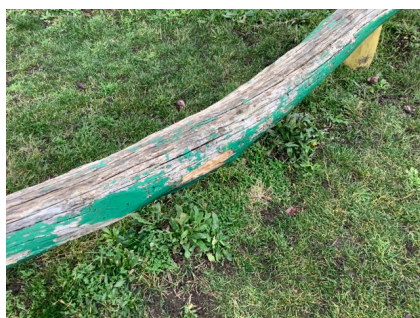
Timber is decayed.

Decay appears to be limited to the outer layers of timber - monitor and sand back any splinted edges as required.

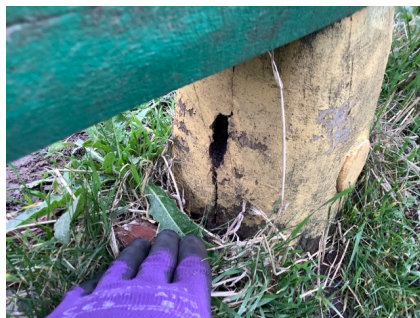
Timber is not in good condition.

Remove rough edges and monitor for decay.

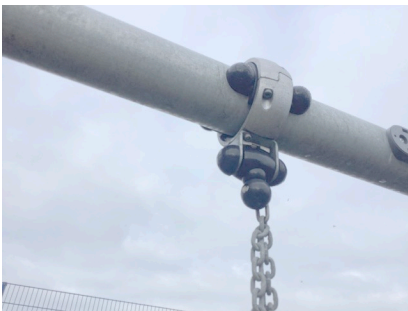
The covers should be removed from the fitting at the top of the chain annually and the shackle bolt should be checked for wear.

Replace at 70% of original diameter (30% wear).
